MARYLAND GEOLOGICAL SURVEY Merryman Hall The Johns Hopkins University Baltimore, Maryland 21218 (301) 235-0771

COUNTIES (MD/PA)	WASHINGTON/FRANKLIN
M&D milestone no.	94 (97)
MHT-HSI no.	WA-IV-094
	•

FIELD SHEET: MASON & DIXON LINE, MARYLAND-PENNSYLVANIA BOUNDARY MARKER SURVEY

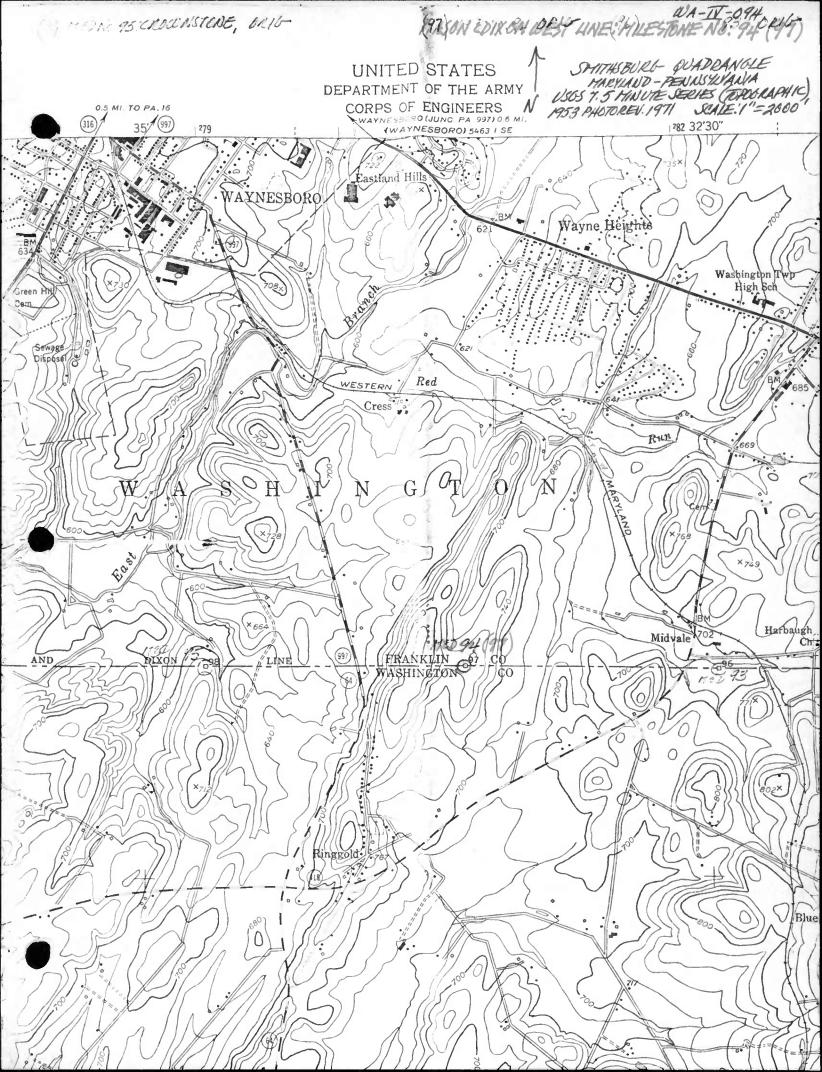
HED WEST LINE; MILEGTONE 94 (97)
VIEW OF STONE 2 SETTING, LOOKING—SE
TOWARD WORTHINGTON FARM
PHOTO: ALICE MARTIN (1981.2.3) 11/22/80
